Investigation Report
COA INV
Internal Accident Investigation

Well control incident Troll 31/2-G-4 B (Songa Endurance)

Classification.: Internal	Status: Final report – released	
Report no.: A 2016-16 TPD L1	Date: 4 January 2017	
Expiry date: 4 January 2027	Synergi no.: 1488377	
Short description: <p>On the 15 October 2016 at 09:32:31 during operations in well 31/2-G-4 at the Troll field, gas from the reservoir started to flow at a rate of approximately 50 kg/second. The water filled marine riser was almost emptied (~55 m³), the water blown onto the drill floor of the rig "Songa Endurance" by the gas. Personnel on the rig managed to stop the gas after about one minute by closing the blowout preventer located at the sea bed.</p> <p>A total of five gas sensors gave 20 % Lower Explosion Limit (LEL) alarm, two on the drill floor, and three in an air inlet to a tool store located just outside of the derrick. The two sensors on drill floor also gave 60 % LEL alarm. No one was injured during the incident.</p> <p>On 16 October 2016, the well was killed by pumping kill fluid to push the gas back into the formation. The tubing was freed for gas 26 October 2016.</p> <p>Based on available info

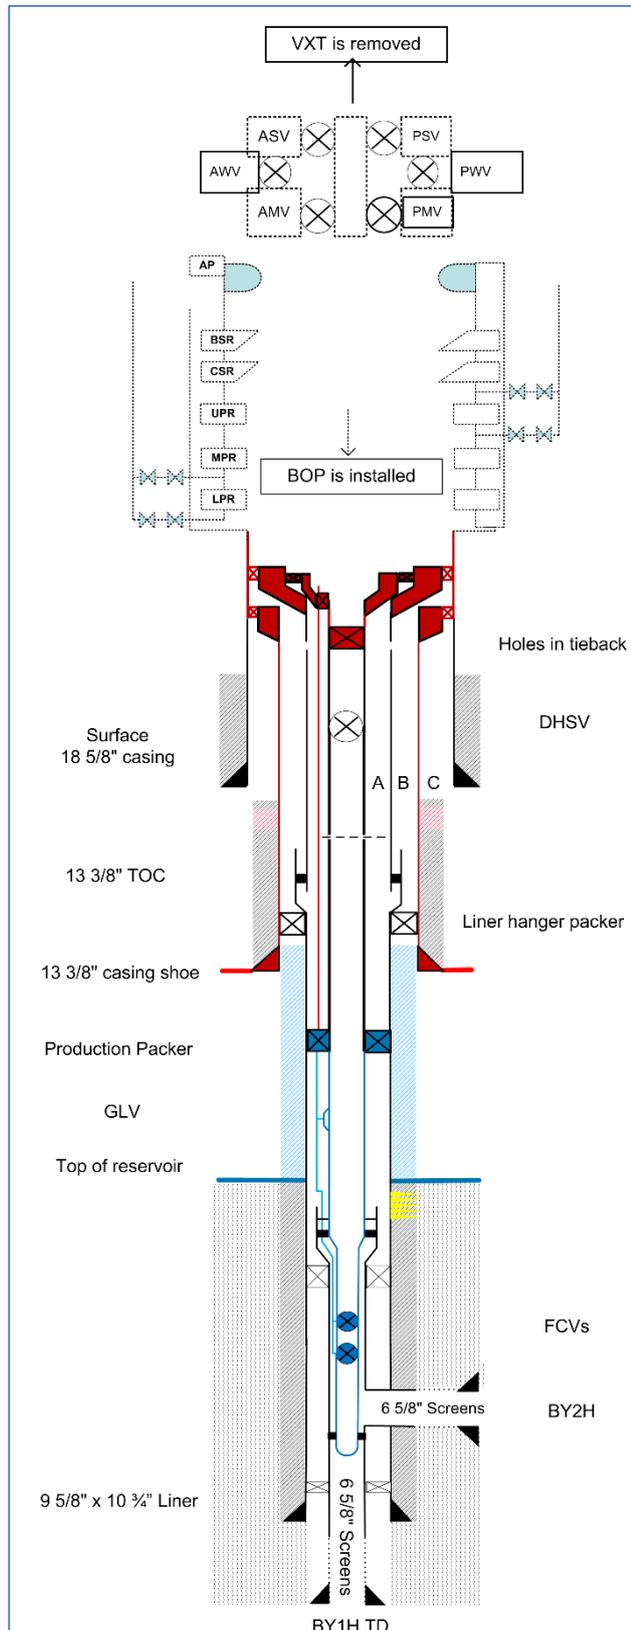
Figure 4-3 Removing XT and installing BOP

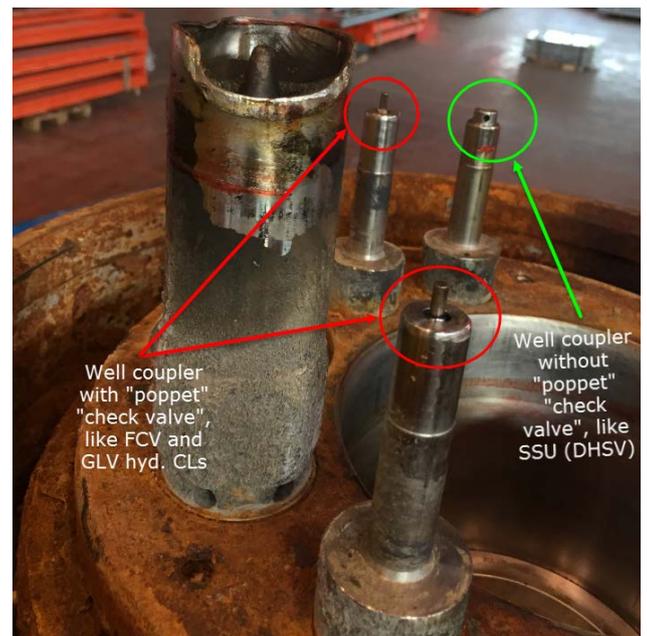
The control lines are protected by so called “poppet valves”, or check valves. These check valves ensure that any gas entering leaking control lines in the well don’t escape above the tubing hanger, but allow pressure acting on the check valves to enter the control lines to the valves, if the pressure is sufficient high. This can operate (cycle) the gas lift valve (GLV) and the flow control valves (FCV).

Check valves for control lines to the GLV and FCV circled in red

Seen from the top of the tubing hanger (Photo from another well).

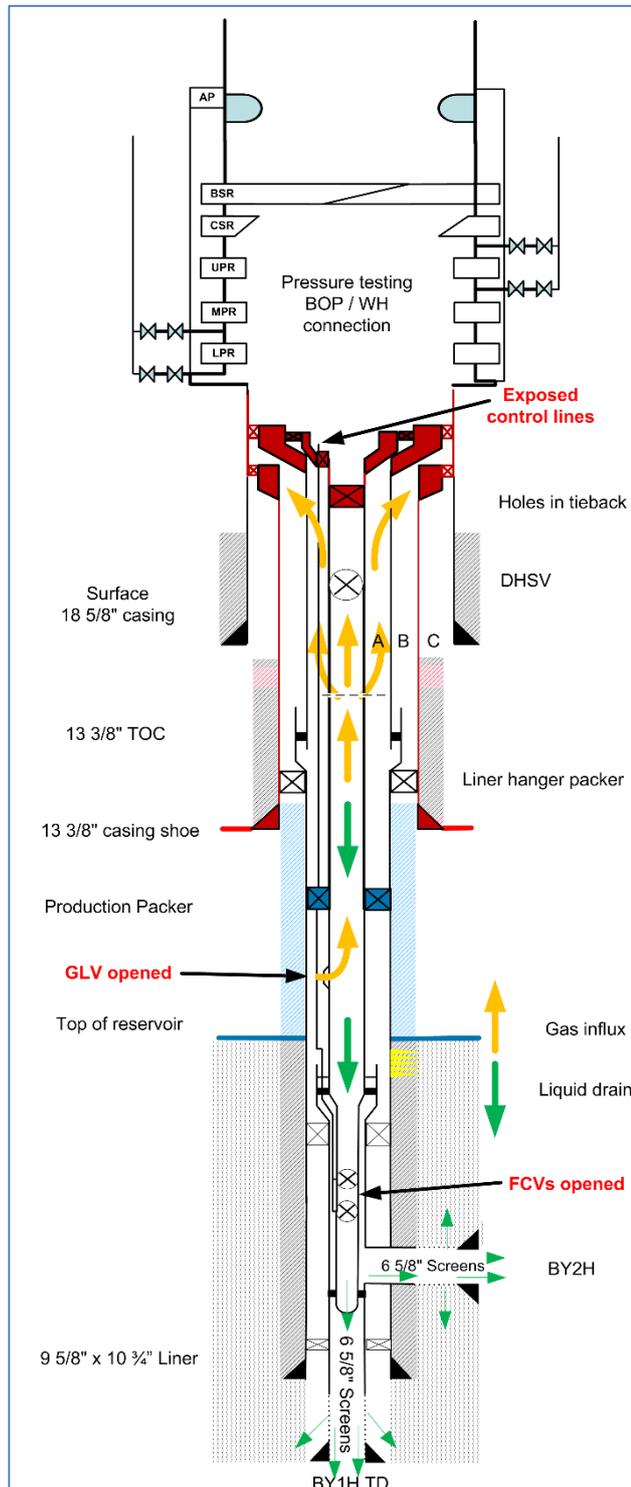
Figure 4-4 Pressure testing BOP /Wellhead connection, cycling Flow Control Valves and Gas Lift Valve open, filling well with gas, draining liquid

The manufacturer of the Gas Lift (GLV) and Flow Control Valves (FCVs) has informed the investigation team that these valves can cycle at pressures as low as 30 bar, considerably lower than the stated “minimum operations pressure” given as 207 bar for both the GLV and FCV, **Ref /1/** shown in **App J**. The “minimum operating pressure” is to be understood as a pressure that guarantees a speedy cycling of a valve, even if the valve has been contaminated after long use. In the investigation team’s opinion, all these valves have therefore cycled from “position 1 fully closed”, to “position 2 fully open”, as shown in **Figure 11-6** and **Figure 11-7** in **App G**. The pressure escapes slowly through the exhaust line in the SLS (see **Figure 3-7**). The investigation team therefore consider it most likely that the valves were only cycled once during this pressure testing. This allowed gas from the reservoir to enter the well through the GLV, pushing liquid in the well through the open FCVs, into the formation. The reservoir in G-4 is so permeable that the fluid in the well will give an immediate loss with gas influx when the FCVs opened, even if the GLV had remained closed. Previous experience on Troll field has shown that a well will be gas filled within hours after opening the flow control valves.

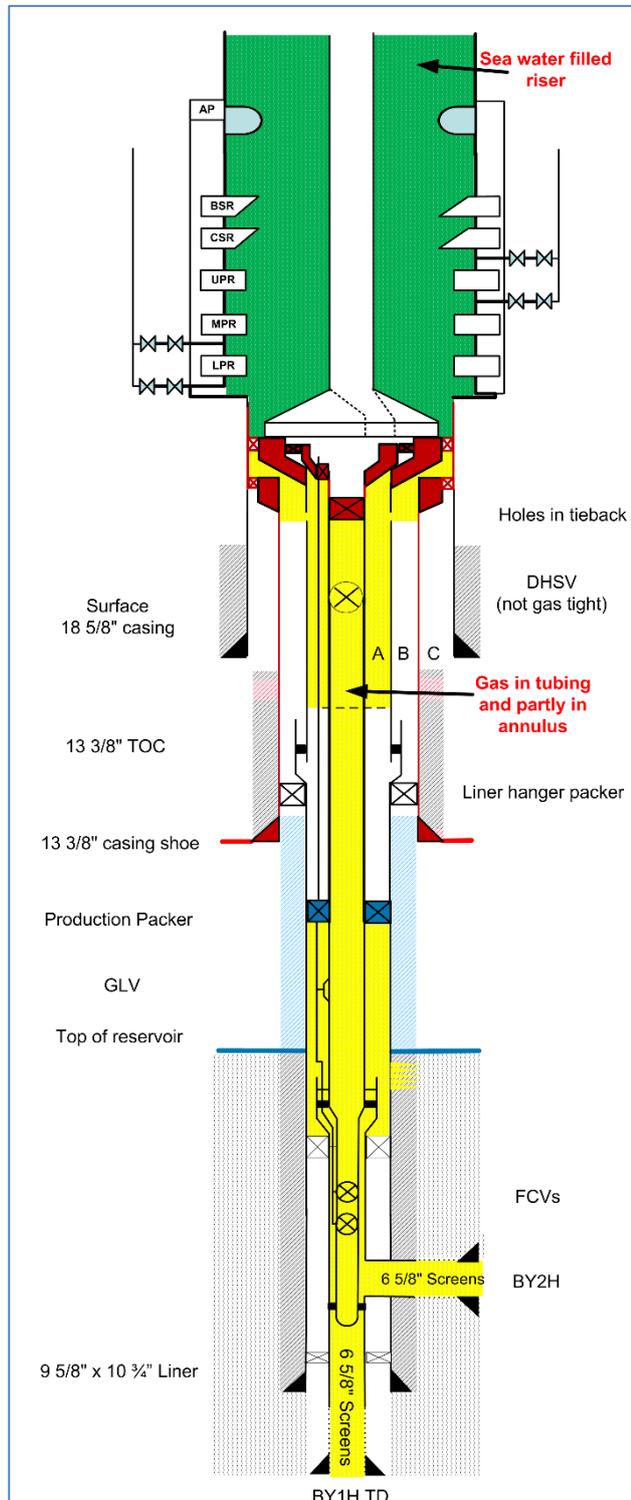
Figure 4-5 Connecting Tubing Hanger Secondary Retrieval Tool to Tubing Hanger

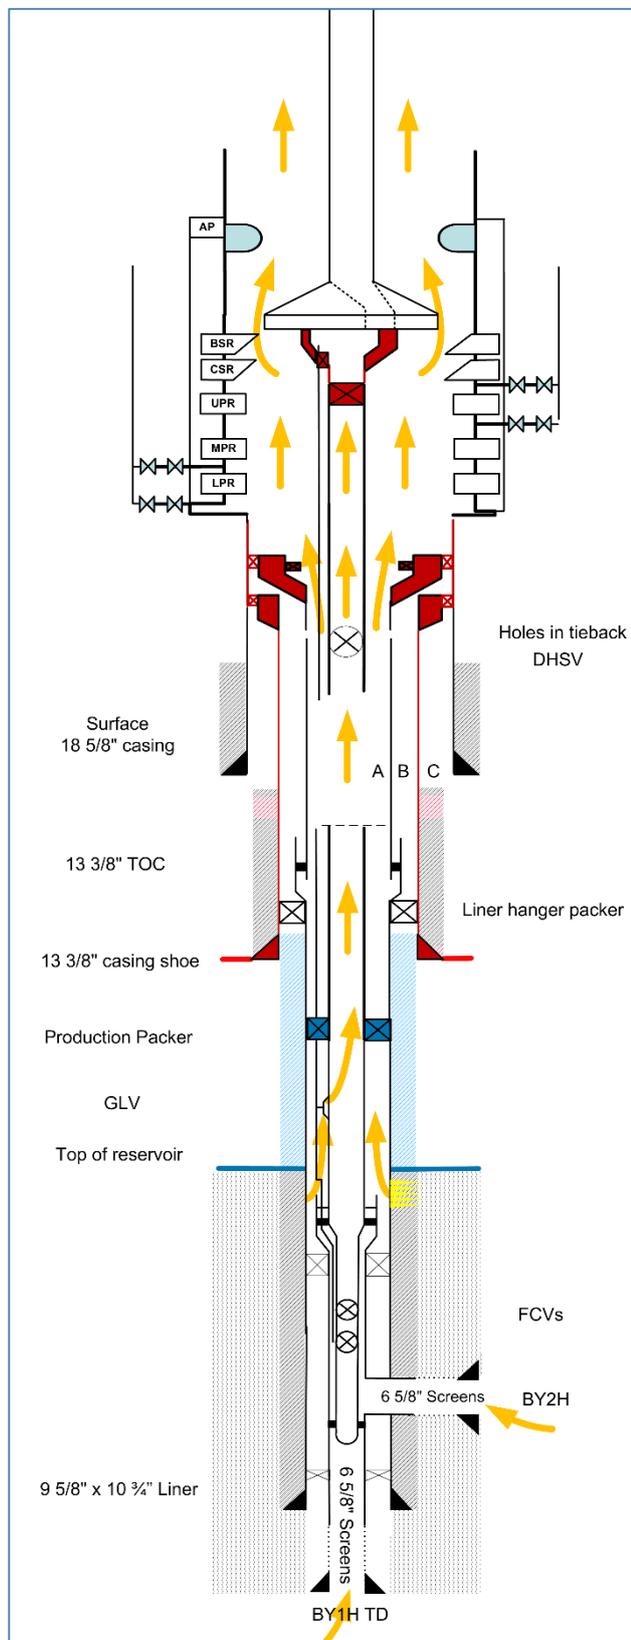
Figure 4-6 Tubing hanger pulled, pushed 6 meters up by gas pressure in well

As the driller had lifted with 13 tons over pull, this over pull collapsed the hold down dogs (released the tubing hanger). The drill string then came up through the rotary, being pushed by the gas pressure (110 bar) in the well. This happened at 09:32:30 according to logged data of the hook load. The sea water filled riser was emptied by the escaping gas. The string came up approximately 6 meters before it halted as the compensator system stroked out. Observation on drill floor showed that water started flowing onto the drill floor 15 seconds after the drill pipe started to move. The pipe was curved due to compression by the upward force from the gas pressure (logs indicate 15-20 ton acting on it). The annular preventer was manually activated 19 seconds later at 09:33:04. Shortly after, there was no visibility; neither from drillers cabin nor in the surveillance cameras on drill floor due to seawater from riser emerging through rotary. Surveillance cameras showed the water column from the marine riser striking the top of the derrick, and being spread horizontally outwards.

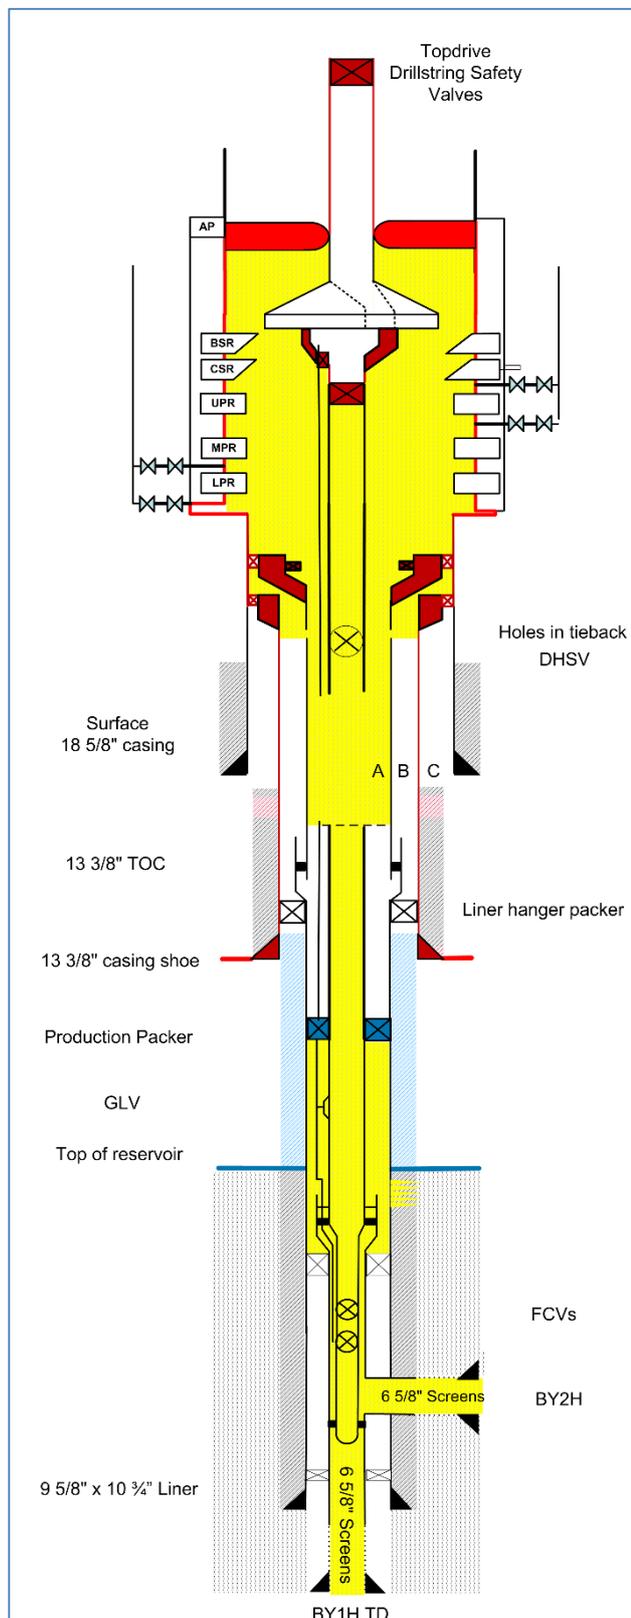
The figure to the left shows both barriers opened when the tubing hanger was lifted out of the wellhead.

Figure 4-7 Annular preventer closed.
The red envelope is the single barrier containing pressure

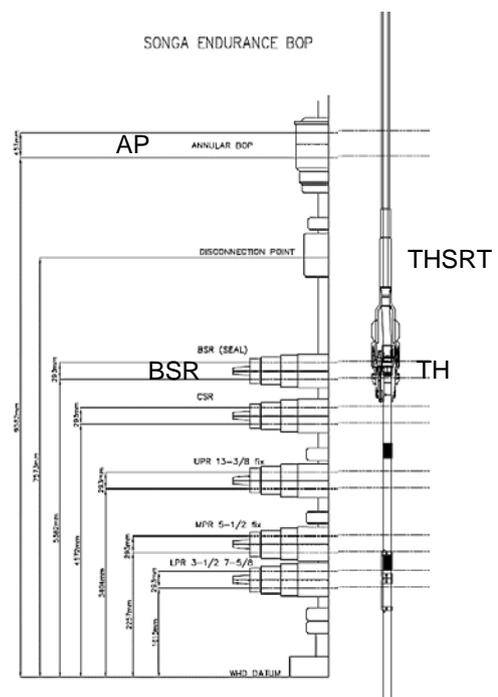
The blind shear ram (BSR) was activated at 09:34:02. This ram system is designed to cut through drill pipe and seal off both gas and liquid from underneath, but is not capable of cutting through pipe connections or thicker parts of tools. It was later discovered that the hydraulic volume used to close the BSR was not sufficient to have closed it completely. This suggested that the BSR had hit a non-shearable part. At a later stage, the BSR EVO lock system, see **section 3.3.4**, was activated. Hydraulic fluid usage was 12 litre compared to 26 litre expected. This also confirmed that the BSR was not fully closed.

When the tool was pulled out of the well, deformation marks on the skirt of the THSRT confirmed the position of the tool in the BOP as shown in the sketch below.

Figure 4-8 Blind Shear Ram partly closed

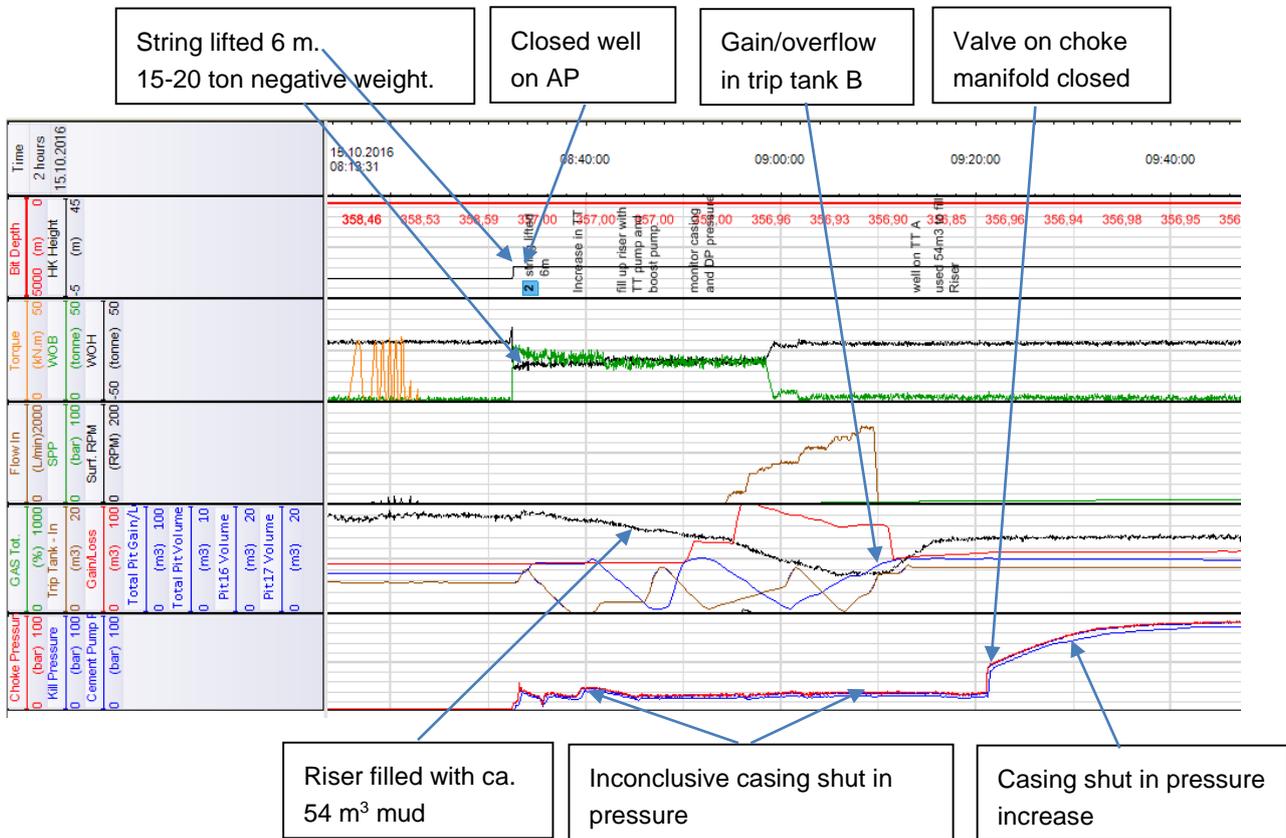
Figure 4-9 Recorded shut in pressure, refilling of riser and gain in trip tank B (Data from Discovery web)

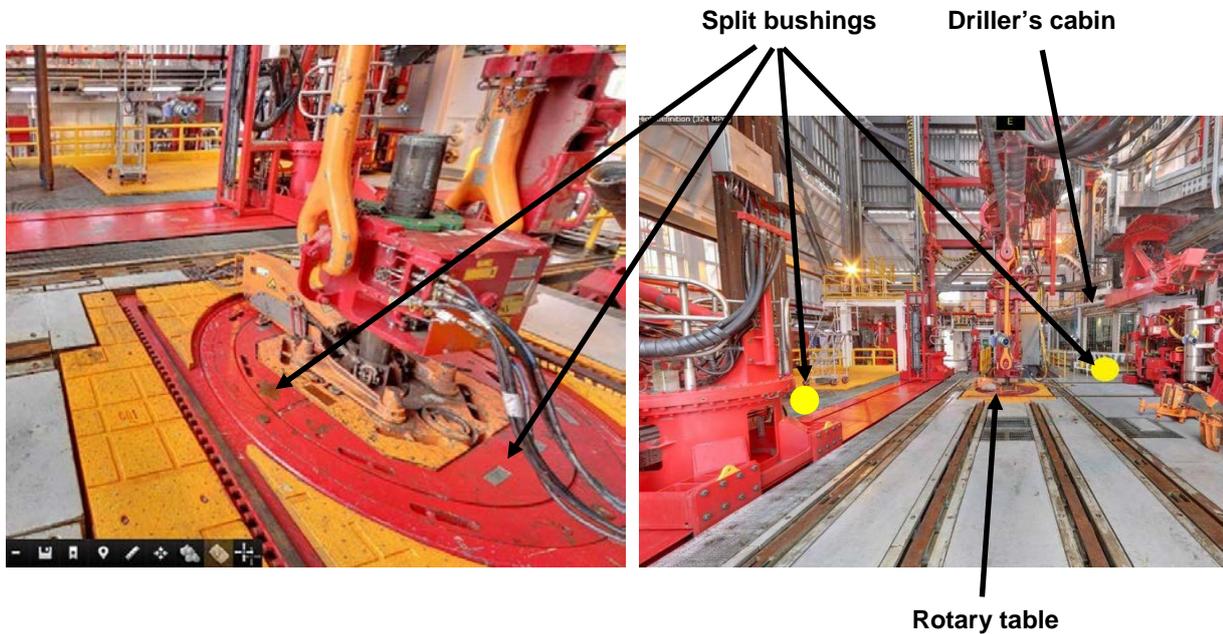
There were no personnel present in the red zone on drill floor during the incident. Unless documented in a risk analysis, the red zone is unmanned when equipment is in motion. In this incident, the two halves of the split bushing (each weighing approximately 1 000 kg) were lifted out from their location in the rotary by the emerging sea water from the riser, and moved several meters to each side. The yellow circle to the right indicates where one of the bushings landed, it was close to the driller’s cabin. The windows are protected by steel grating, but most likely would not have been able to stop the heavy split bushing if it had hit. In case of an explosion, other objects could also have hit areas inside and outside of the drill floor. Personnel in the driller’s cabin would also most likely have been fatally injured if the gas had ignited, see section **5.3.5**.

Figure 5-4 Rotary table with split bushings

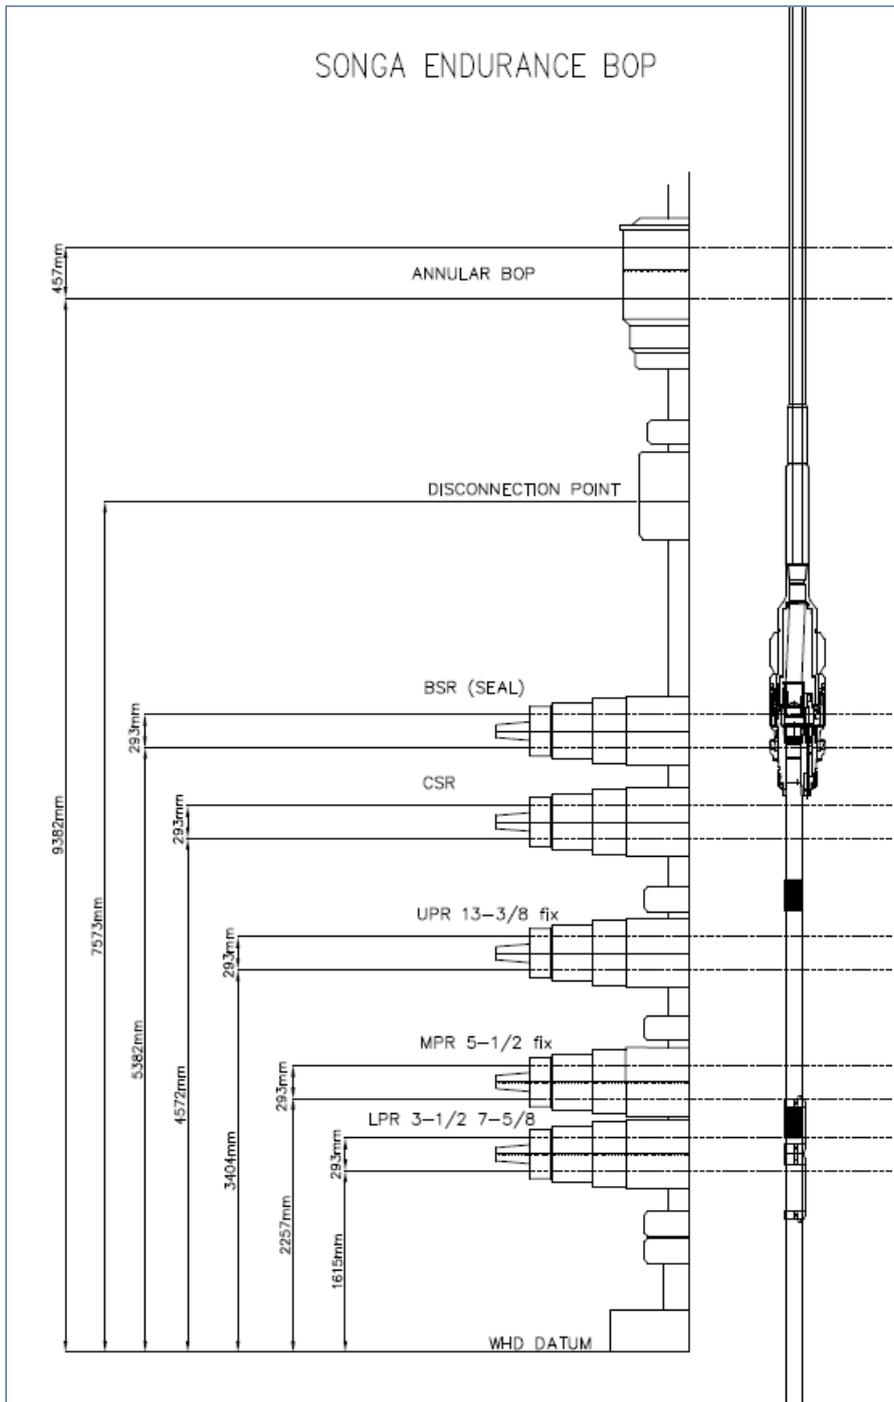
Figure 6-3 Approximate location of THSRT in BOP
