Investigation Report
COA INV
Internal Accident Investigation

Well control incident Troll 31/2-G-4 B (Songa Endurance)

Classification.: Internal	Status: Final report – released	
Report no.: A 2016-16 TPD L1	Date: 4 January 2017	
Expiry date: 4 January 2027	Synergi no.: 1488377	
Short description: <p>On the 15 October 2016 at 09:32:31 during operations in well 31/2-G-4 at the Troll field, gas from the reservoir started to flow at a rate of approximately 50 kg/second. The water filled marine riser was almost emptied (~55 m³), the water blown onto the drill floor of the rig "Songa Endurance" by the gas. Personnel on the rig managed to stop the gas after about one minute by closing the blowout preventer located at the sea bed.</p> <p>A total of five gas sensors gave 20 % Lower Explosion Limit (LEL) alarm, two on the drill floor, and three in an air inlet to a tool store located just outside of the derrick. The two sensors on drill floor also gave 60 % LEL alarm. No one was injured during the incident.</p> <p>On 16 October 2016, the well was killed by pumping kill fluid to push the gas back into the formation. The tubing was freed for gas 26 October 2016.</p> <p>Based on available info

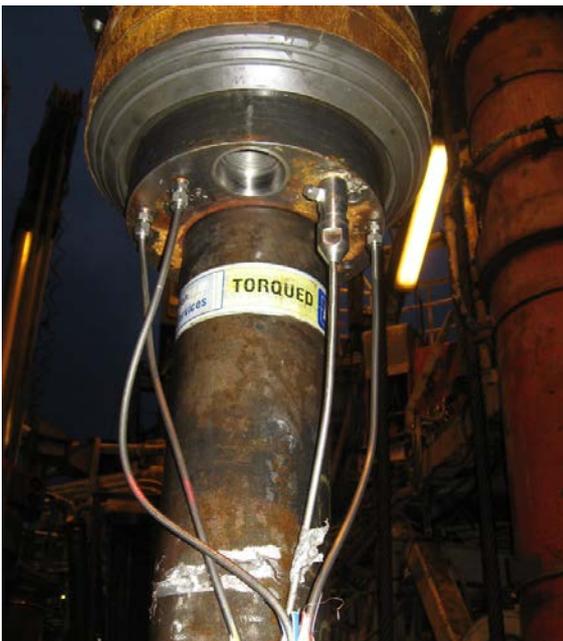
Figure 3-6 Photo showing the control lines coming from valves, entering the tubing hanger (seen from below tubing hanger)

The low operating volumes and low differential pressure over the balanced piston necessary to operate the valve, along with the “Fail As Is” functionality demands particular attention to unintentional pressure increase of the control lines to the valves.

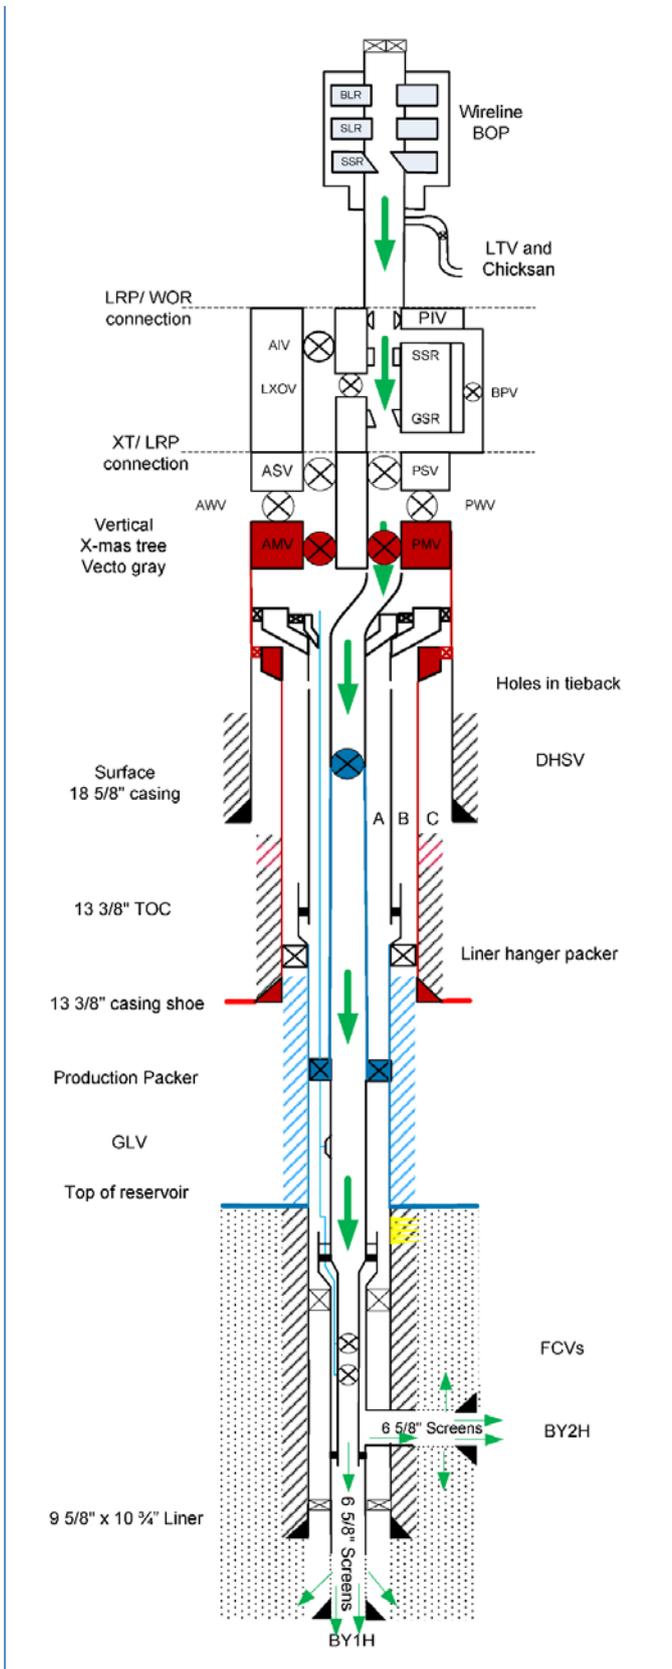
Figure 4-1 Killing well through wireline BOP / XT

Well G-4 was killed (displaced hydrocarbons with fluid) 20.09.2016 by pumping 107 m³ fluid (8 m³ base oil slop and 99 m³ 1,03 seawater) through the open flow control valves (FCV).

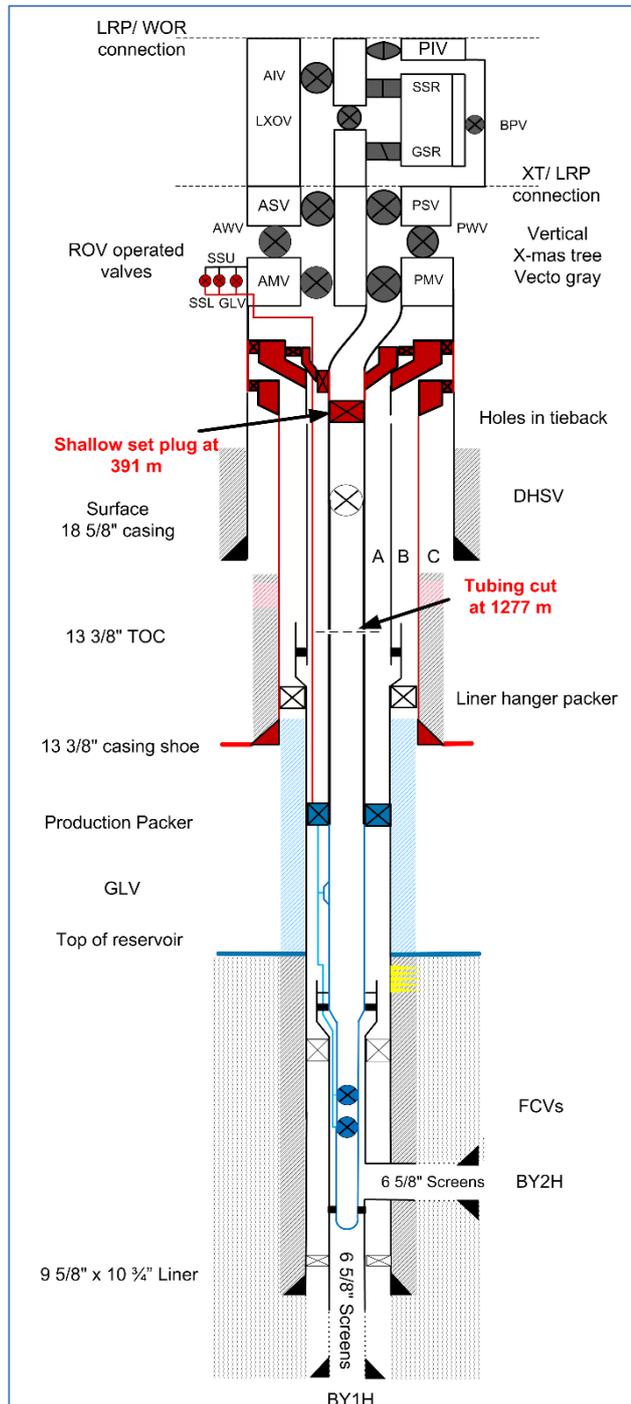
The tubing was cut at 1277 m on 20.09.2016 at 21:30

A shallow plug was set at 391 m and pressure tested to 190 bar on 21.09.2016 at 04:00.

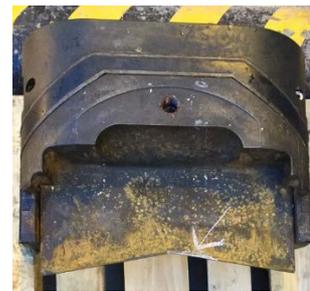
Figure 4-8 Blind Shear Ram partly closed

The blind shear ram (BSR) was activated at 09:34:02. This ram system is designed to cut through drill pipe and seal off both gas and liquid from underneath, but is not capable of cutting through pipe connections or thicker parts of tools. It was later discovered that the hydraulic volume used to close the BSR was not sufficient to have closed it completely. This suggested that the BSR had hit a non-shearable part. At a later stage, the BSR EVO lock system, see **section 3.3.4**, was activated. Hydraulic fluid usage was 12 litre compared to 26 litre expected. This also confirmed that the BSR was not fully closed.

When the tool was pulled out of the well, deformation marks on the skirt of the THSRT confirmed the position of the tool in the BOP as shown in the sketch below.

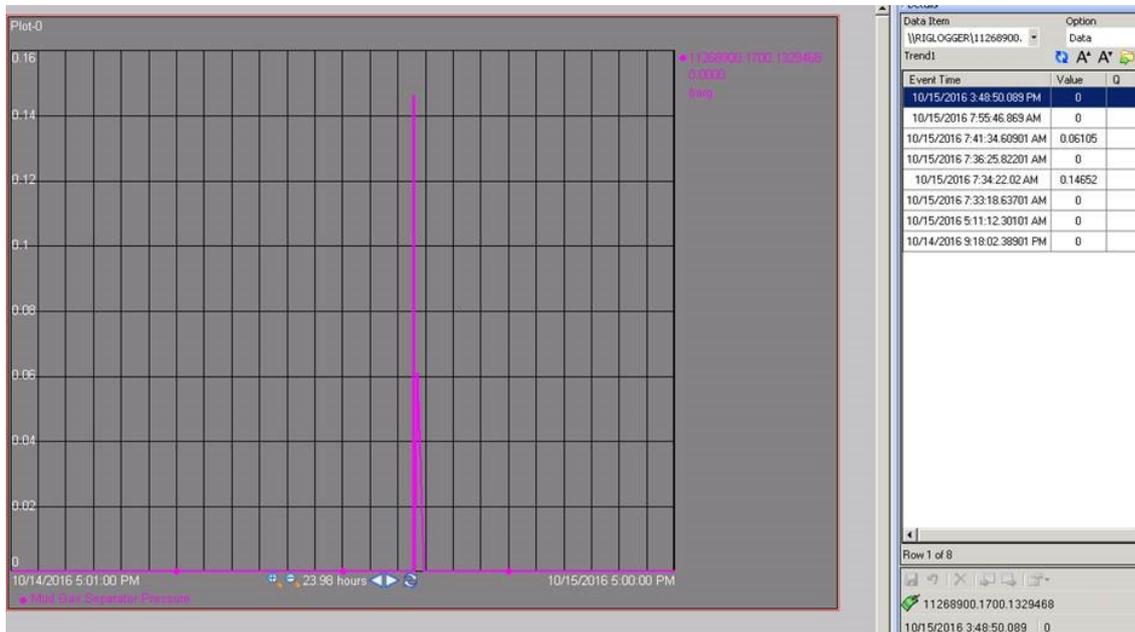
Figure 4-10 24 hour recorded pressure in Mud Gas Degasser
(Note: Add two hours to get Norwegian time zone)

Pressure data from the mud gas separator shows two low (0.15-0.06 bar) measurements from 09:34:22, less than a minute after the well was shut in (09:33:41). This may indicate that gas or fluid has been entering the mud gas separator, but the recorded measurements are too few to be conclusive. Readings are shown in **Figure 4-10** and **Figure 4-11**.

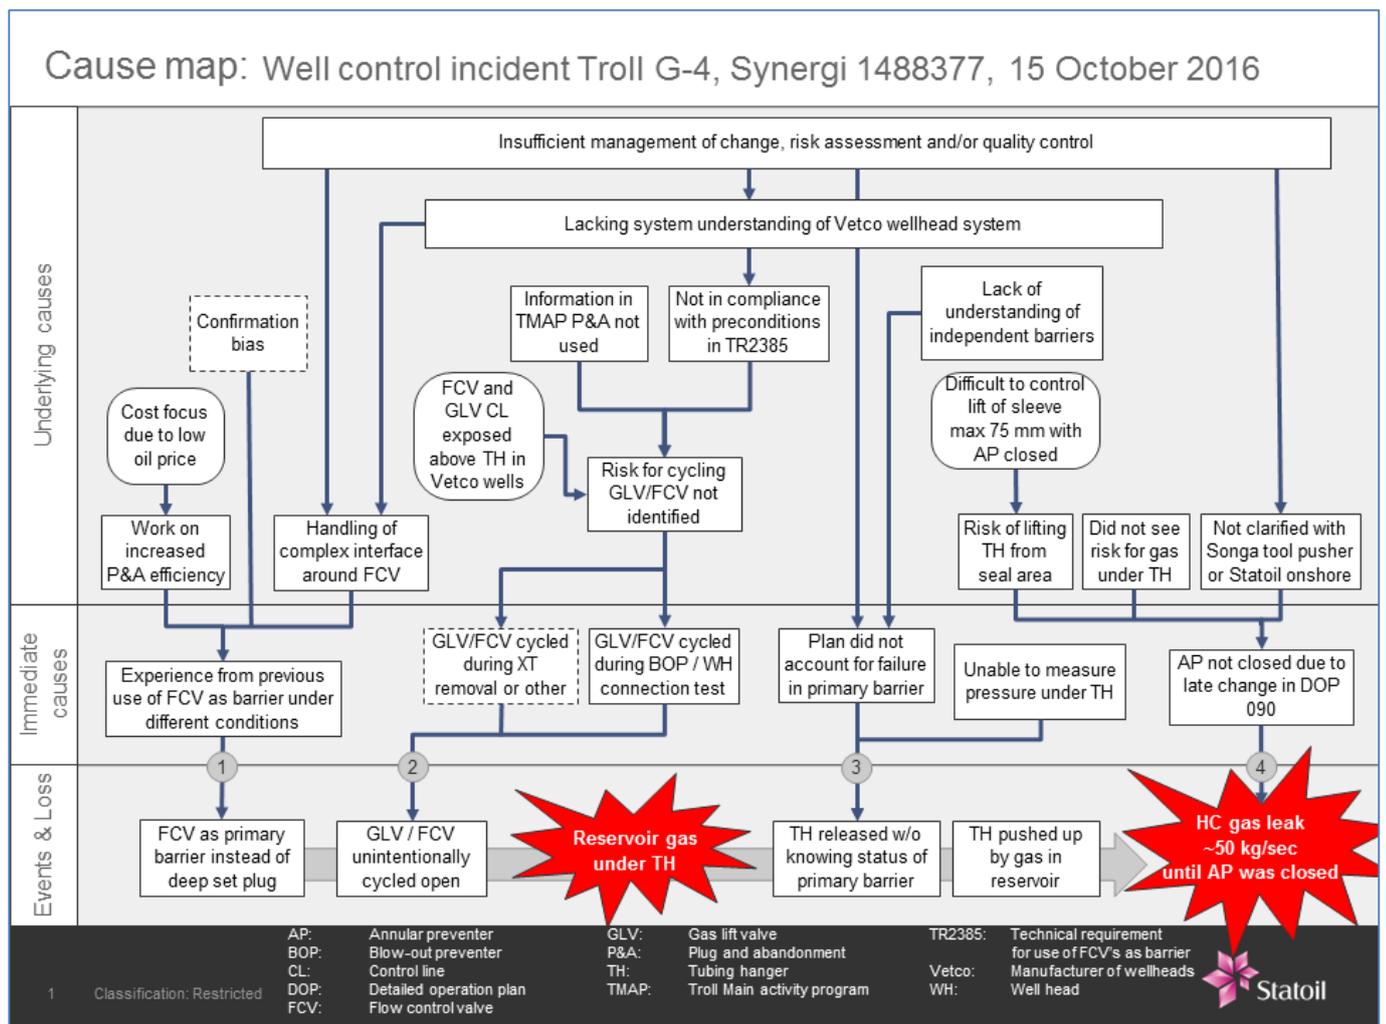
Figure 6-1 Cause map

The Cause map (see **Figure 6-1**) provides an overview of the causes of the incident. The map shows the events that led to the unwanted consequence/loss, the immediate causes (unwanted/dangerous action or condition that triggered one or more single events), underlying causes and the relationships between them. The Cause map is established based on the description of sequence of events given in **chapter 4**.

The investigation team has utilized a system-oriented approach to the investigation work. Rather than focusing on a single error or failure, the system approach views the causes of the incident as an interconnected web of technical problems, decisions, design issues, operational practices, organizational factors etc. which worked together to cause the incident.

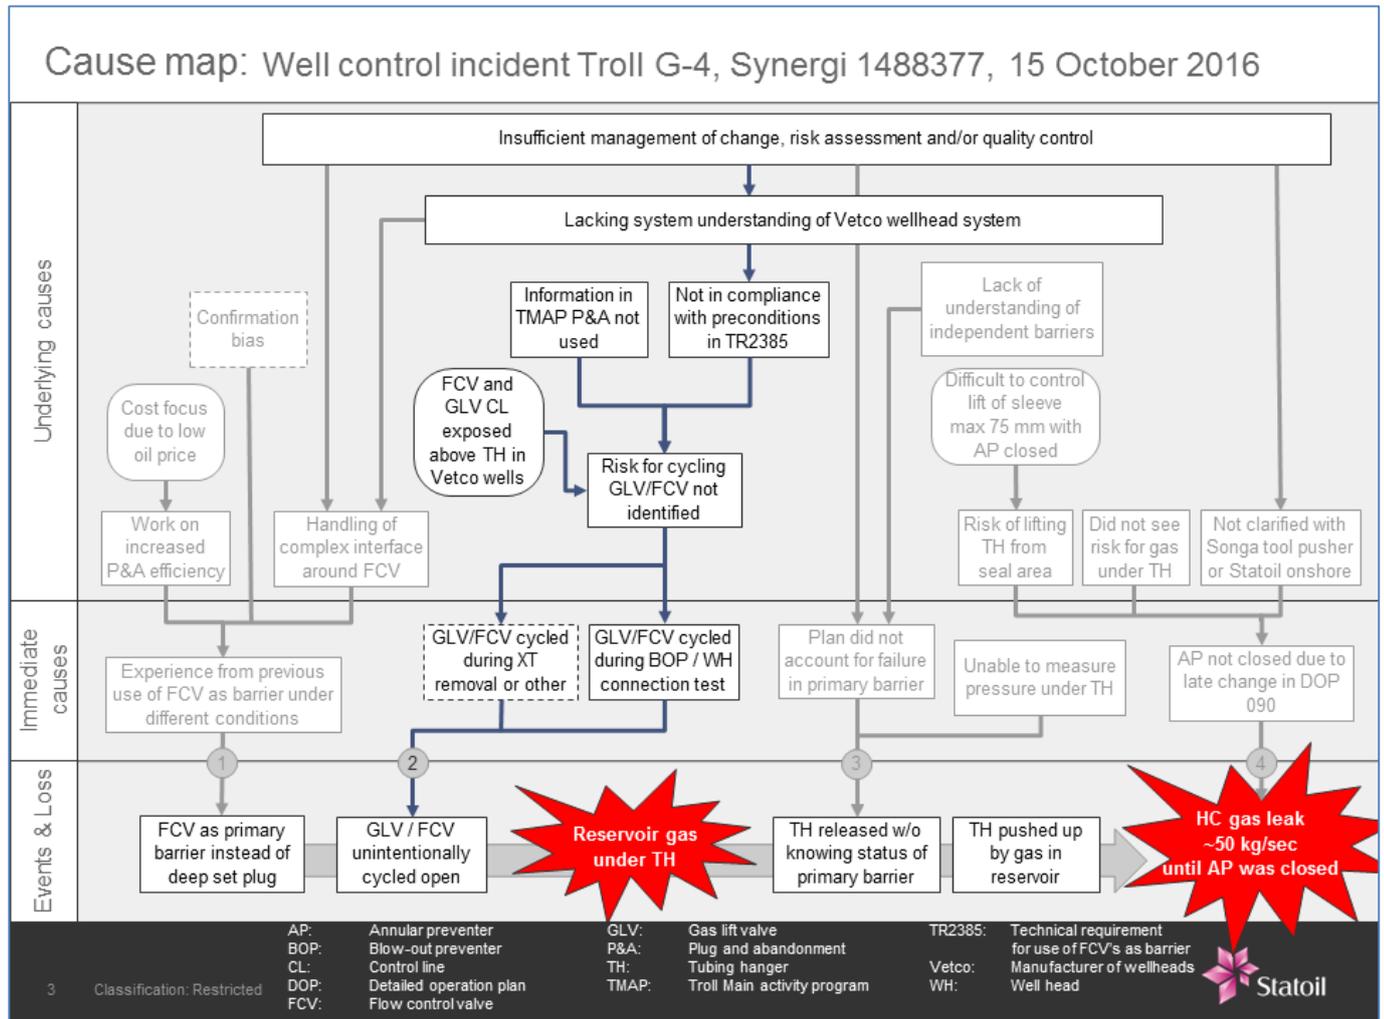
Table 6-2 Immediate and underlying causes of Gas Lift Valve / Flow Control Valve unintentionally cycled open

Cause	Description	Effect
Immediate cause/action		
GLV/FCV cycled during XT removal or other operation	<p>After Baker Hughes's last cycle of FCVs and GLV and following pressure test of tubing the control line were connected to WOCS. It is possible to operate the FCV/GLV from the Work Over Control System (WOCS).</p> <p>When the XT was removed, pressure in the seal test area was applied to help lift off the XT.</p>	<ul style="list-style-type: none"> -Unintentional operation of WOCS could operate FCV/GLV. -Unintentional pressure build up in return system in WOCS could cycle FCV/GLV -Damage to control line during cut of tubing could cause a leak in control line and a pressure increase of 30 bar to FCV/GLV due to heavier fluid in annulus. This potential also occurs later when pulling tubing and rupturing control line. -Pressure assist retrieval of XT (performed in DOP 070 Chapter 8 Item 9) could allow pressure to leak into control line for and cycle FCV/GLV, but is very unlikely according to the manufacturer

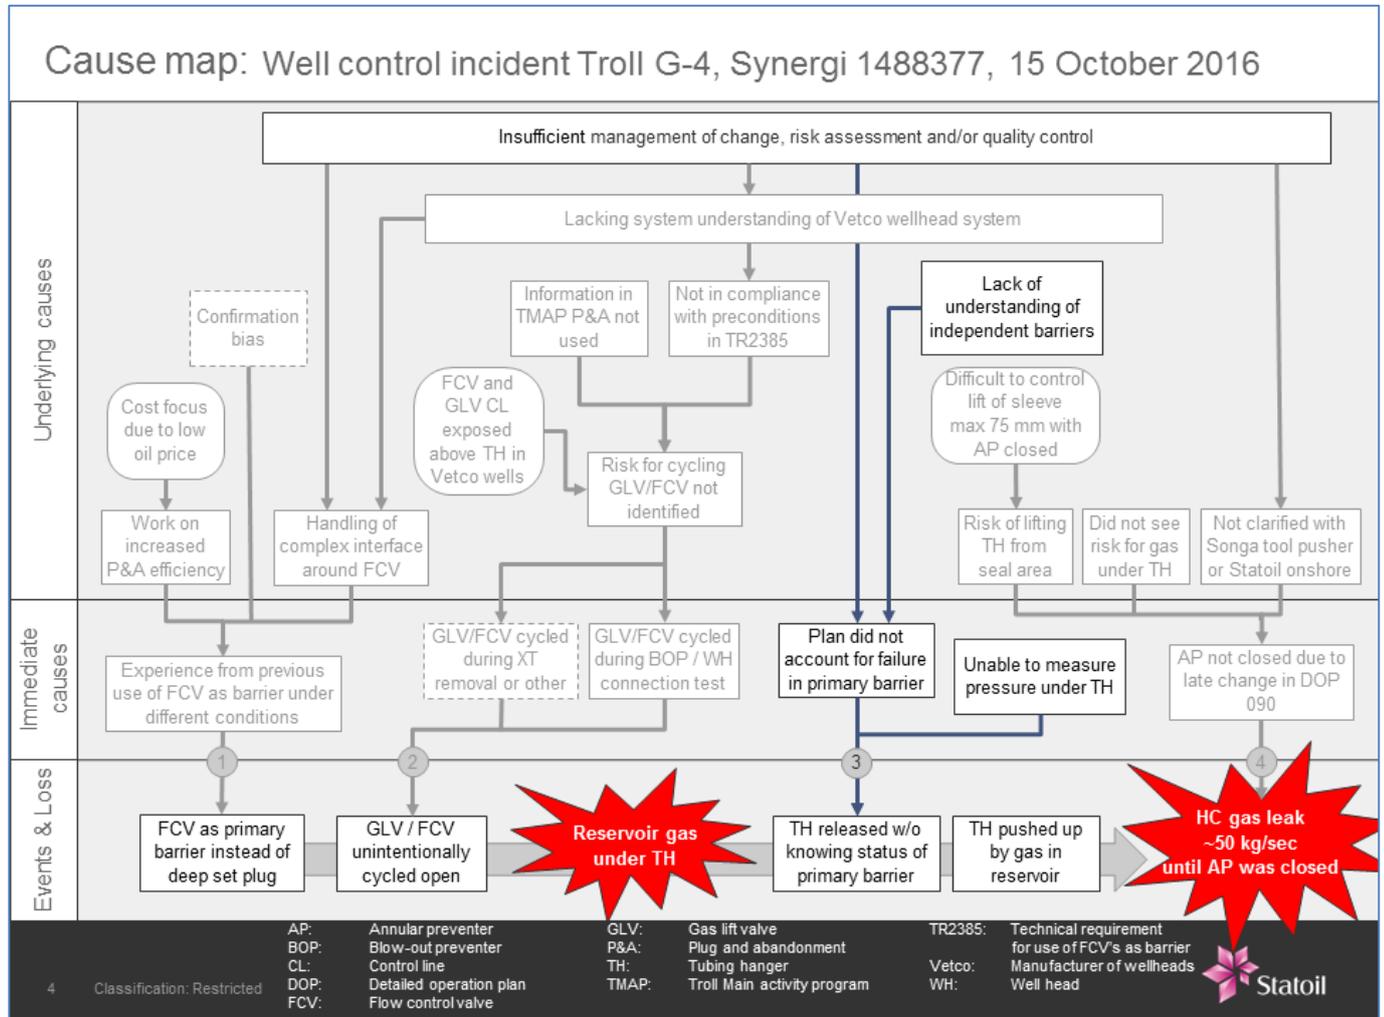
6.3 Causes linked to Tubing Hanger released without knowing status of primary barrier

Underlying causes		
Lacking understanding of independent barriers	Any two-barrier operation or situation has to cater for failure of one barrier element. The very reason for operating with a secondary barrier is to have a backup in case the primary barrier should fail.	Operation did not cater for the possibility for full reservoir pressure below shallow plugs inside the tubing
Insufficient management of change, risk assessment and/or quality control	It has become an established routine on Troll to pull tubing without monitoring for pressure under tubing hanger / shallow plug, as requested in TR3507. This has not been common on other fields in Statoil. Some interviewees have mentioned “The Troll way” in a negative manner, meaning that “we have done similar operations many times, they are standardized and simplified”. In this event, this could have a negative impact related to attention to robust, independent barriers and change management	The decision to not use a deep set mechanical plug made the barriers in this operation less robust

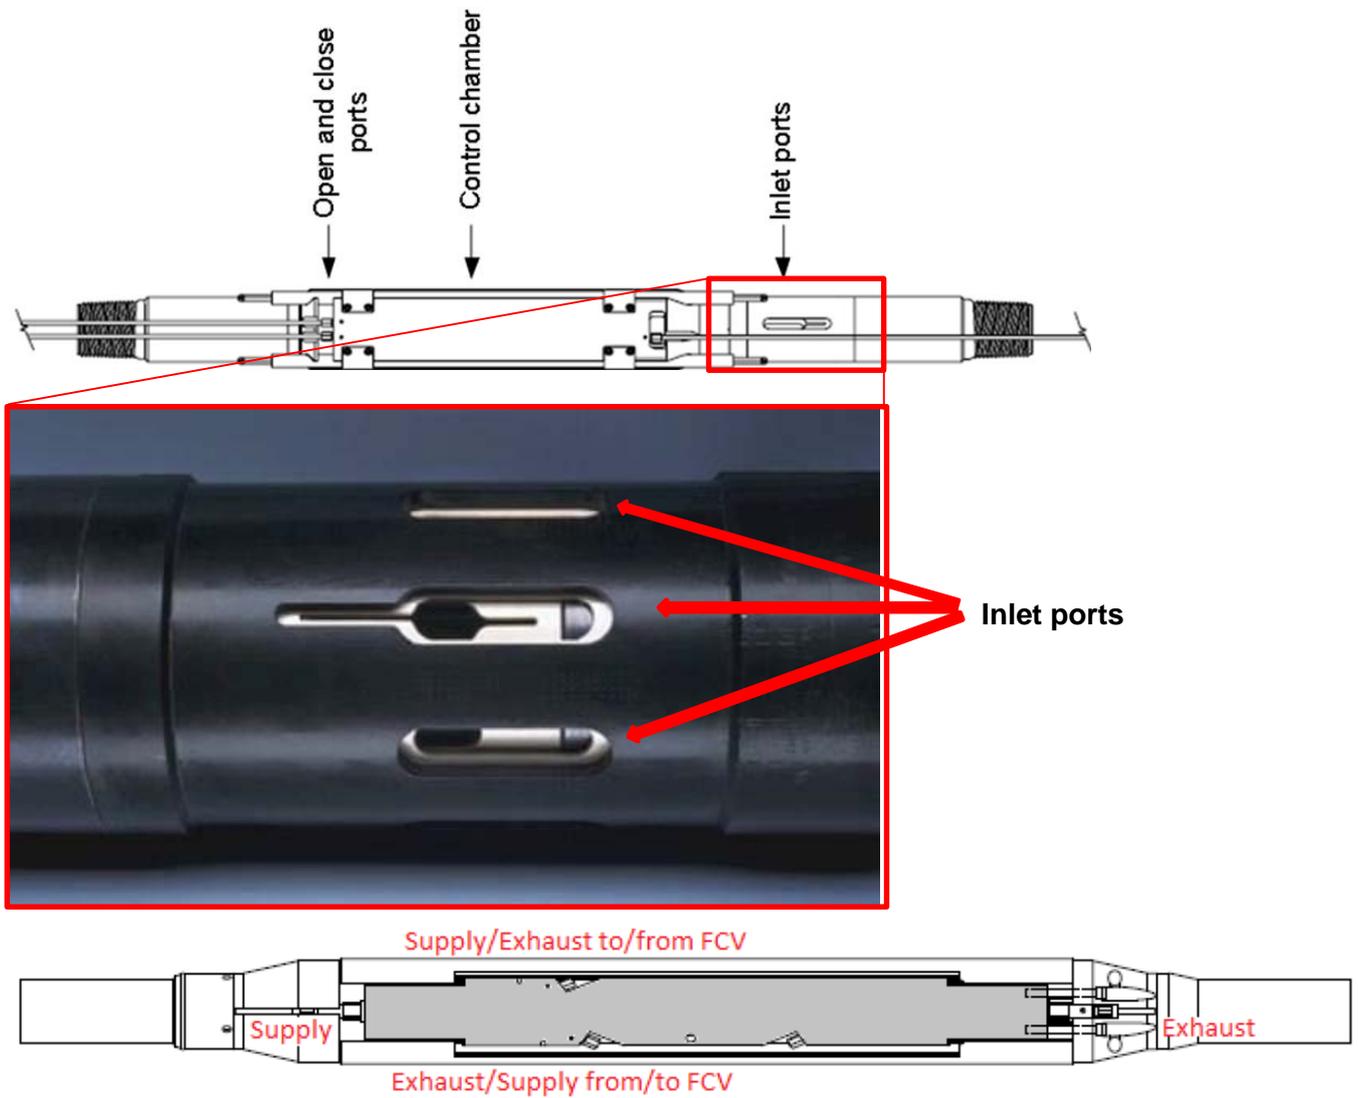
Figure 11-5 Overview and detail of the HCM-A Flow Control Valve in well G-4

The SLS piston has a metal-to-metal seal with its chamber, resulting in a small leakage rate past the piston. This is purposely designed to prevent hydraulic lock, but results in operational consequences. The SLS minimum shifting pressure is approximately 200-400 psi (14-28 bar). This low pressure means the SLS can shift with unintentional pressure spikes, declining pressure or thermal expansion. An unintentional shift of the SLS is called a “blind shift” and this is confirmed when pressure is increased expecting to get a pumped in or return volume and sees almost no volume. The solution is to bleed off below 200 psi, wait according to procedure stated time, and pressure up again.

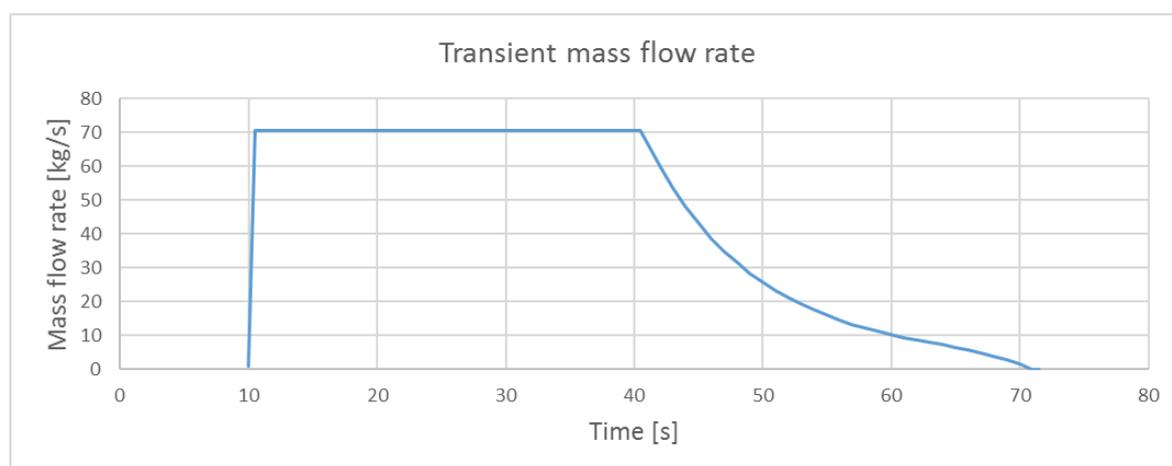
Fig. 5. Transient flow rate as function of time, calculated in FLACS jet program

- Target initial flow rate was 70.7 kg/s
- Annulus preventer started closing after 30 s, i.e constant flowrate of 70.7 kg/s the first 30 seconds
- Total leak duration: 60 s
- Gas velocity and impulse are represented correctly by using the jet program
- Volume of riser: Assumed that the riser was filled with gas, and by the time the water was displaced, the annular BOP was completely closed. Total gas volume $V_{\text{gas}} = 56 \text{ m}^3$

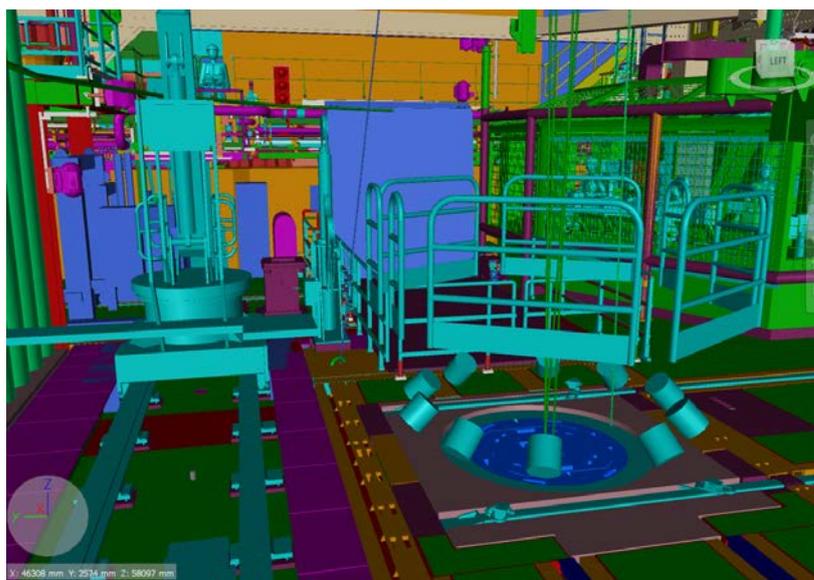
Fig. 7. PDMS geometry detail of discharge location

The PDMS 3D geometry shows numerous equipment around the drill hole, including an annular railing as shown in Fig. 7. To summarize, the possible present restrictions in the flow path and obstructions of the gas flow is not fully understood, which leaves a precise modeling of the discharge challenging. To match observations and FLACS simulations, several cases have been run as explained below.

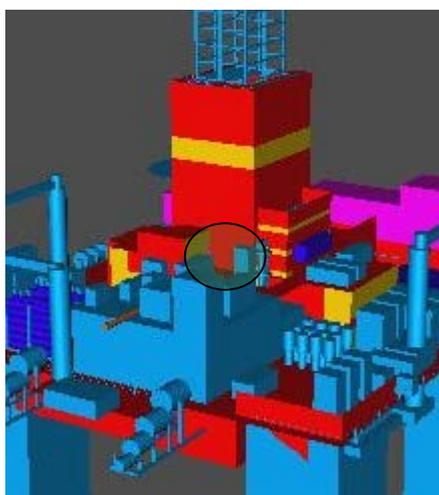
The event log shows that four gas detectors was activated during the event (ref. App B). The first gas detector was activated with a 20% LEL alarm after approximately 55 seconds; the gas detector is located outside the derrick area, in the HVAC intake M606, marked with a black circle in Fig. 8. Gas detection outside the derrick indicate that the gas leak exit may have been blocked at some elevation; and that the jet was somewhat forced downwards and towards the door opening on the drill floor.

Fig. 8 Geometry model showing closed door on drill floor. Yellow fields seen in the derrick are modelled with 30% porosity in the structure. Black circle denotes the location of HVAC intake M606 and one of the activated HC gas detectors

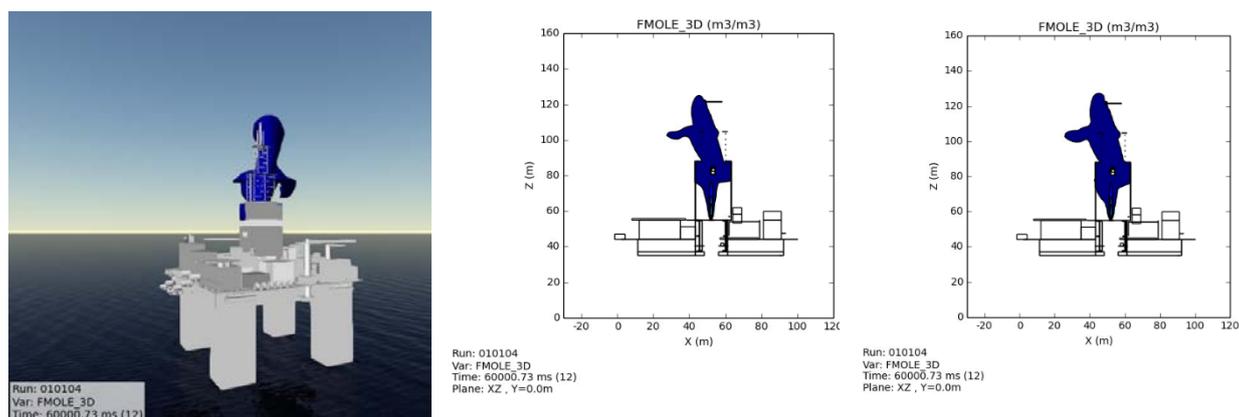
Fig. 11. FLACS results from case 1; Left figure showing 3D plot 1 and right figure showing 2D plot 2 and 3. Concentration level for plot 1 and plot 2 is at 50%LEL, plot 3 is at 20% LEL. All plots shown at timestep t = 60 s

Case 1 and 2 was simulated to see the range and shape of the gas dispersion. As can be seen from Fig. 11 and Fig. 12, the gas dispersion is directed vertically upwards above the weather cladding and the dispersion is governed by the wind.

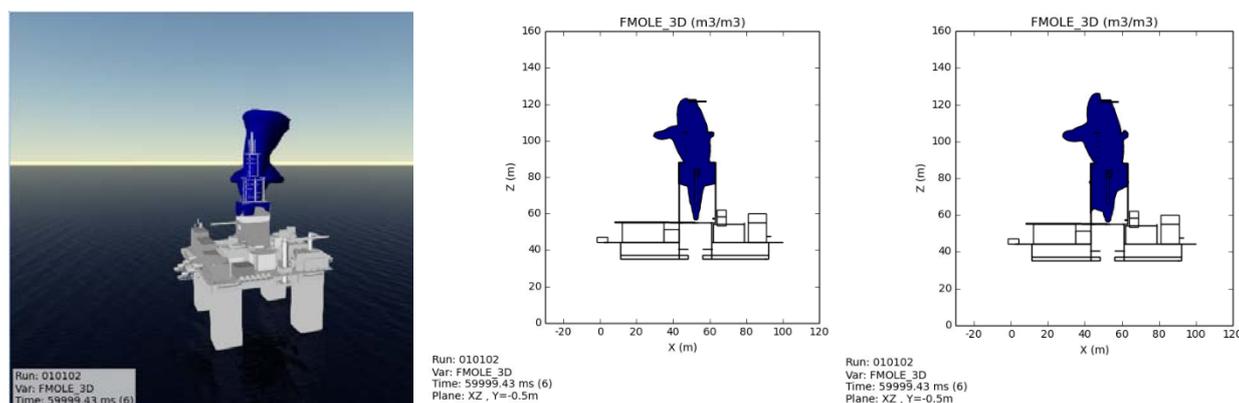
Fig. 12. FLACS results from case 2; Left figure showing 3D plot 1 and right figure showing 2D plot 2 and 3. Concentration level for plot 1 and plot 2 is at 50%LEL, plot 3 is at 20% LEL. All plots shown at timestep t = 60 s

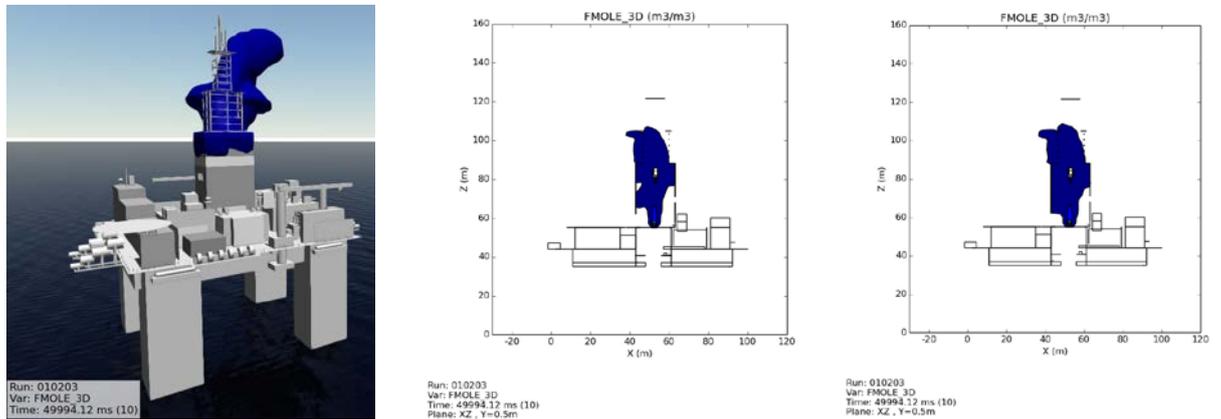
Fig. 13. FLACS results from case 3; Left figure showing 3D plot 1 and right figure showing 2D plot 2 and 3. Concentration level for plot 1 and plot 2 is at 50%LEL, plot 3 is at 20% LEL. All plots shown at timestep $t = 50$ s

Case 3 was simulated to investigate the transient mass flow rate from the start of the gas leakage up to a duration of 60 seconds, ref. Fig. 13. The leak direction was vertically upwards. The results show a dispersion with the same development as case 1 and case 2 initially, but as the flow rate starts to drop, the gas cloud size is reduced accordingly. The second transient release (case 4) was simulated with the jet directed towards the door opening in the derrick, as shown in Fig. 14. Results show that monitors located in the HVAC intake were activated (~8%vol).

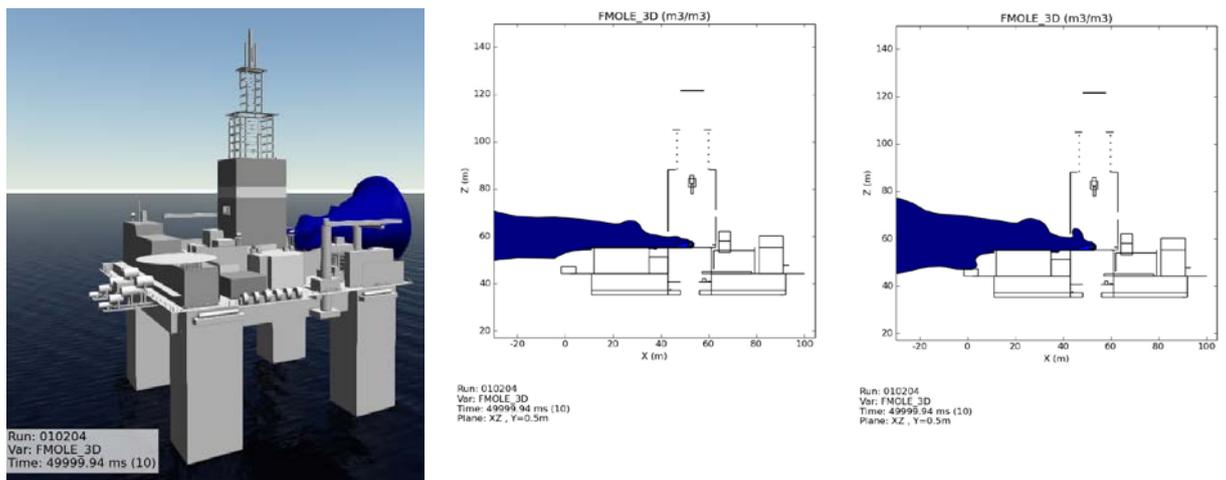
Fig. 14. FLACS results from case 4; Left figure showing 3D plot 1 and right figure showing 2D plot 2 and 3. Concentration level for plot 1 and plot 2 is at 50%LEL, plot 3 is at 20% LEL. All plots shown at timestep $t = 50$ s

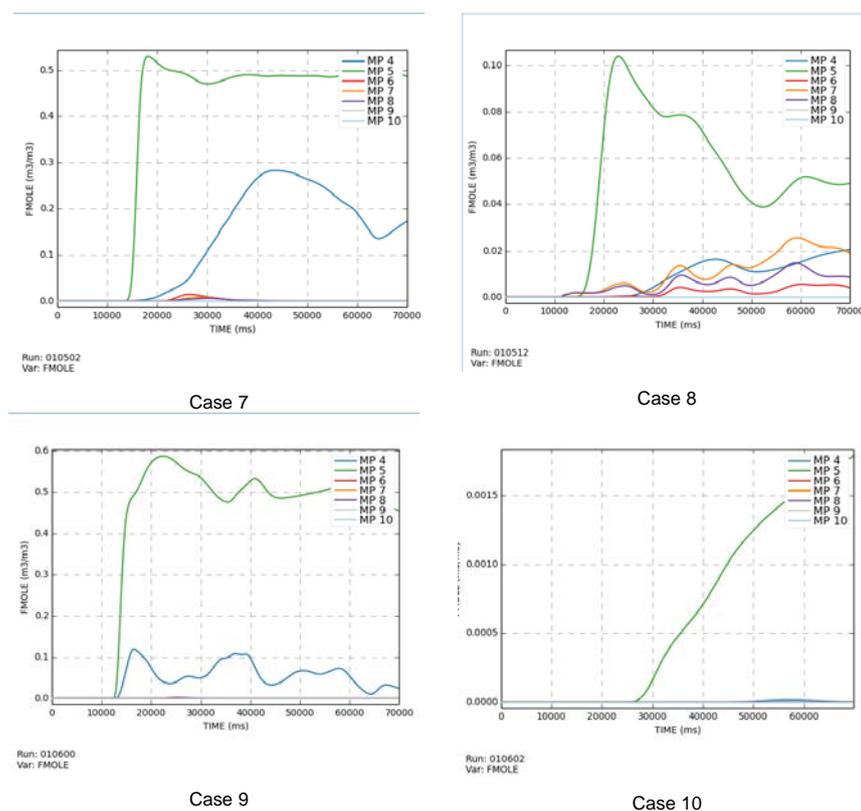
Fig. 21. FLACS results showing volume mole fraction (FMOLE) as function of time in the event for four different scenarios

Simulated cases with 20%LEL gas concentration detected by monitors are listed in Table 5. Results from monitors are shown in Fig. 21.
