Investigation into helicopter safety in Statoil following the Turøy helicopter accident on 29 April 2016

Investigation Report COA INV

Helicopter safety in Statoil following the Turøy helicopter accident on 29 April 2016

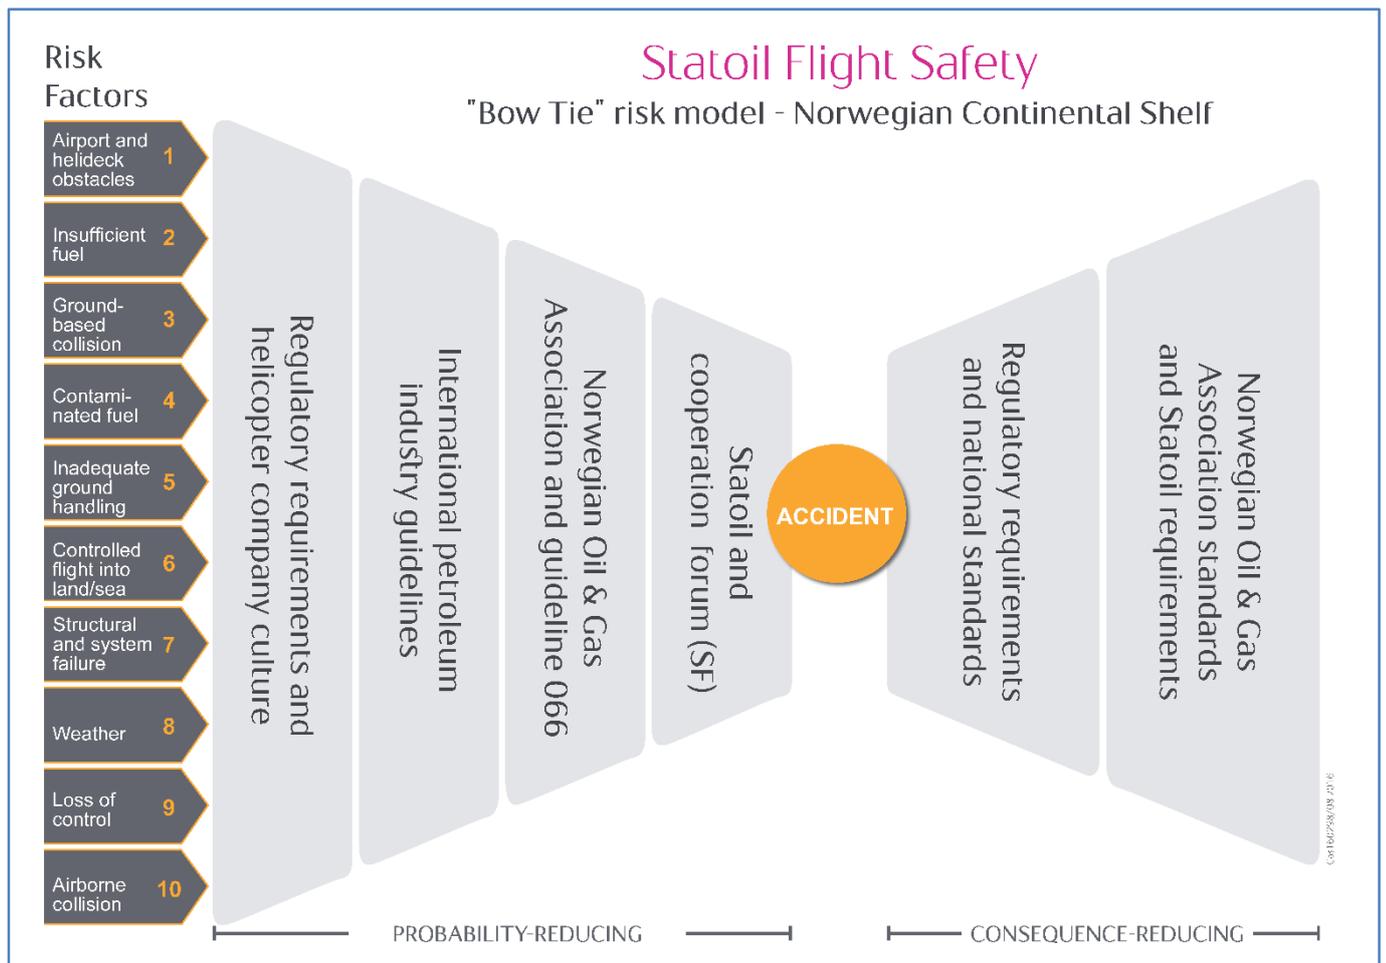
Figure 3-1 "Bow Tie" risk model for the NCS (Source: Statoil flight safety department)

Figure 3-1 shows the barrier approach (the "Bow Tie" model) which forms the basis of helicopter safety work on the NCS (a more detailed description can be found in App B). The left-hand side of the model shows the measures, requirements and provisions which reduce the *probability* of an accident. These are called probability-reducing measures or conditions, and also *barriers*, since they prevent nonconformities and initial undesired incidents from being able to escalate into a more severe accident situation (e.g. an emergency landing at sea). The right-hand side of the model shows the measures, requirements and provisions that reduce the *consequences* of an incident that has occurred, and these are also intended to prevent further escalation of an incident. In the incident scenario of an emergency landing at sea, typical requirements for personal locator beacons, training in emergency evacuation from the helicopter and the SAR service are good examples of consequence-reducing measures that increase the probability of personnel survival.

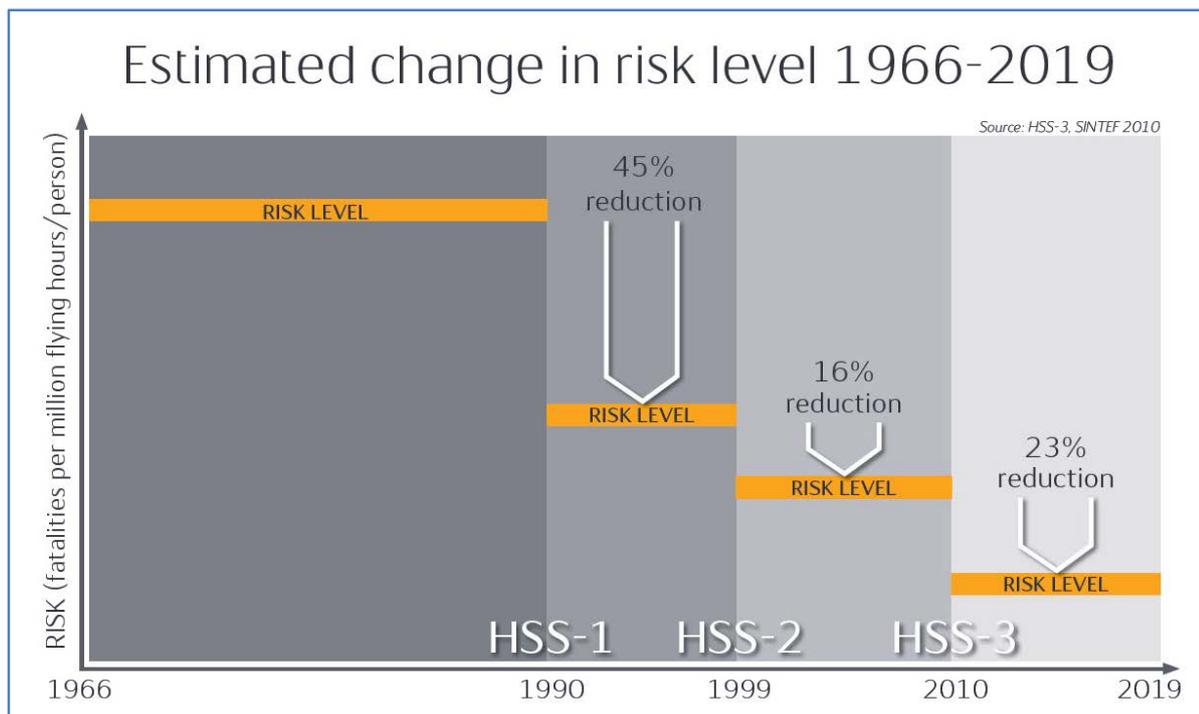
Figure 3-2 Estimated changes in risk level 1966–2019 (Source: HSS-3, SINTEF, 2010)

Figure 3-2 shows the estimated reduction in risk in the three periods examined in the helicopter safety studies. In HSS-2 the level of risk reduction between the two first periods is estimated to have been 45%. In HSS-3 a further risk reduction of 16% was estimated for the next study period (1999–2009), with a further 23% for the following decade (2010–2019). The last risk reduction estimate assumed that the improvements planned for 2010 would be carried out, ref. **App C**. In addition, further risk reduction will be achieved by implementing several of the proposed safety-enhancing measures.
